**Follow along with us as we cruise onboard our
56' Ocean Yacht.**

January 7, 2022 – Friday – Day 31

Woo Hoo – we are getting serviced today!

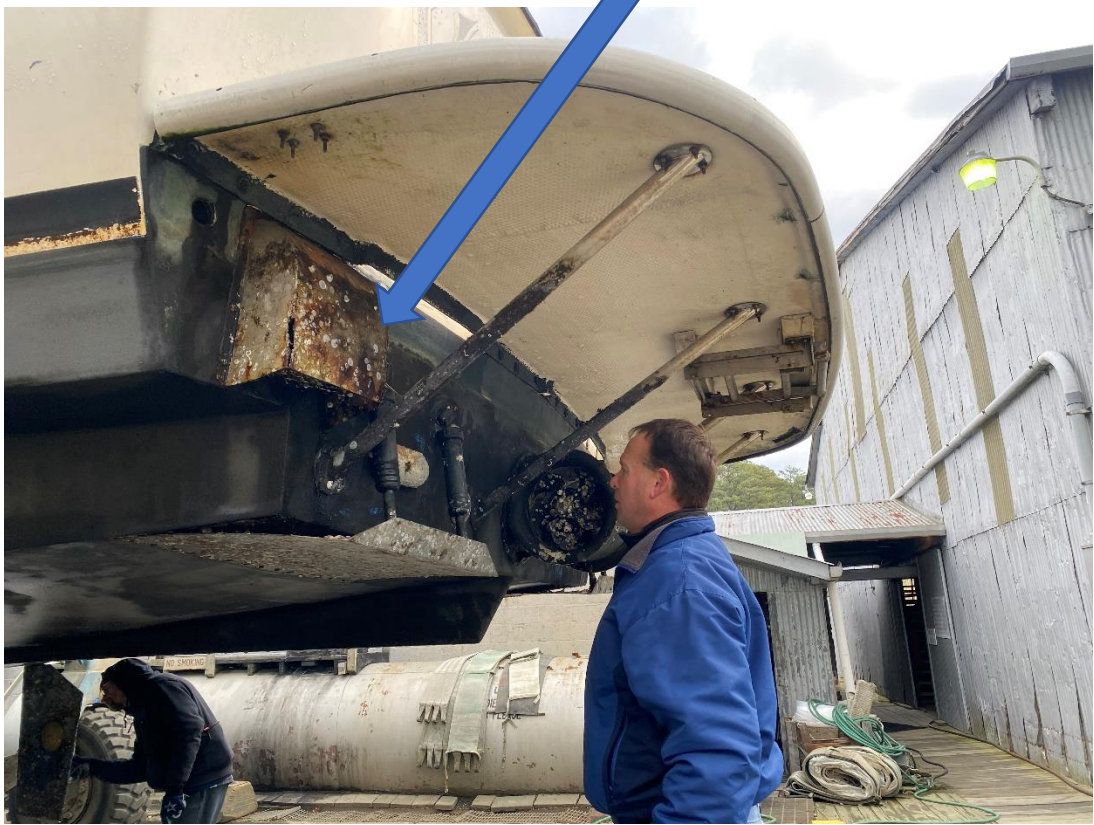
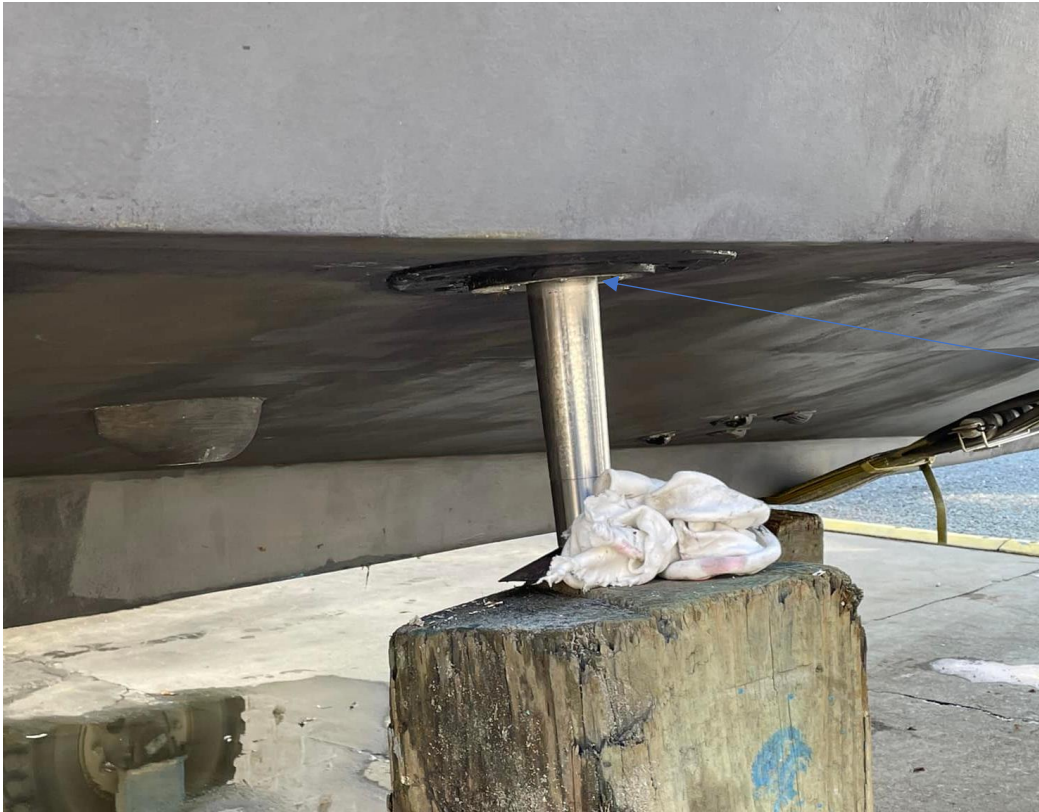
This is the starboard stabilizer side shaft. The fin has already been removed. New seals were installed.

And, up inside that, you cannot see is the connecting rod shaft link that was also replaced.

The seals on the port side were also replaced as part of routine maintenance.

The stabilizer fin was believed to be broken back when we were cruising into Atlantic City, NJ. We were hitting big waves head-on. When we were overtaken by a large boat as we entered the Elizabeth River (Norfolk, VA) we rolled significantly from that boat's wake. The fins would have probably tried to maximum travel or tried to attain maximum travel while we took that wake on the back quarter and because of the existing stabilizer fin issue it caused damage to the connecting rod shaft link.

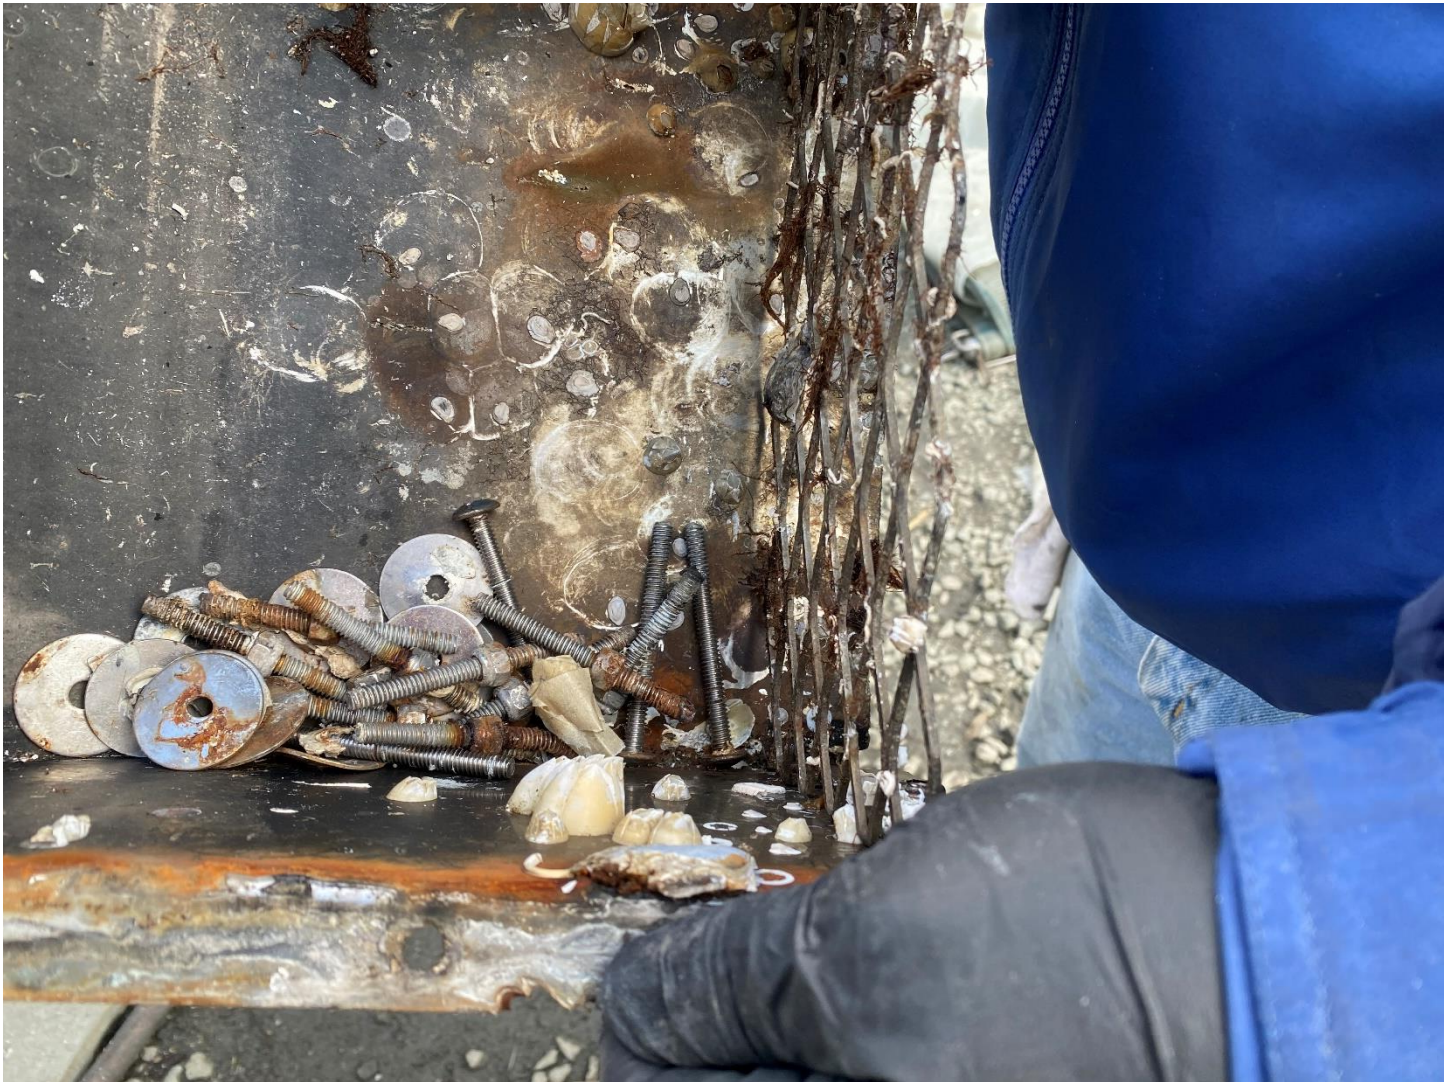
This is the muskrat guard Mark removed. See some of the crustaceans on it? There were plenty of those that he and the workers scraped off different areas along the bottom of the boat, the propellers, thrusters, etc.

A Muskrat, Water Rat, Otter, or other vermin, **can and will, swim up the exhaust.** They chew through a coupling hose to the inside of the boat or make a den. This also includes boats with underwater exhausts. ...

They can cause enough damage to make a boat sink.

Mark removed them to help the engines run more efficiently and breathe better. Boats are frequently running & moving do not have that problem.

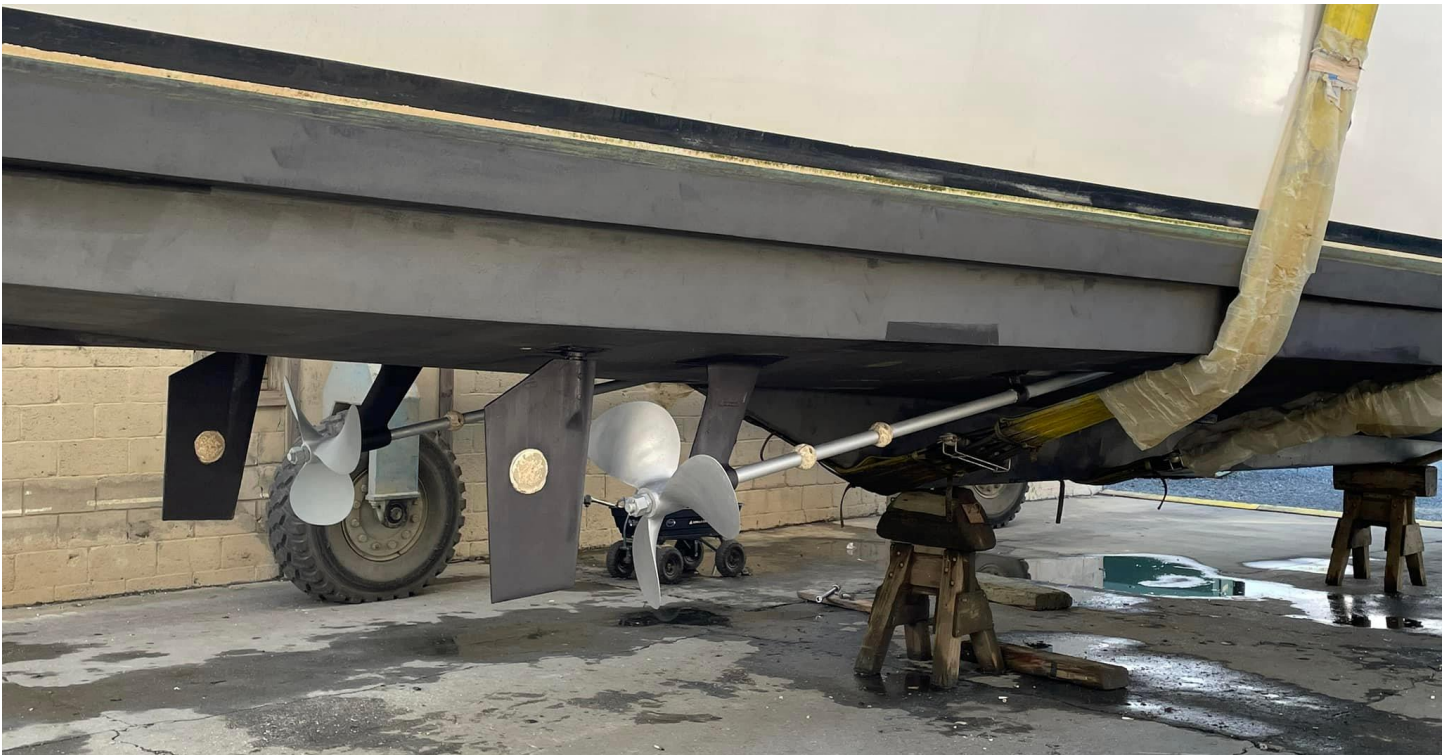
Pre muskrat guard removal.
Post muskrat guard removal.

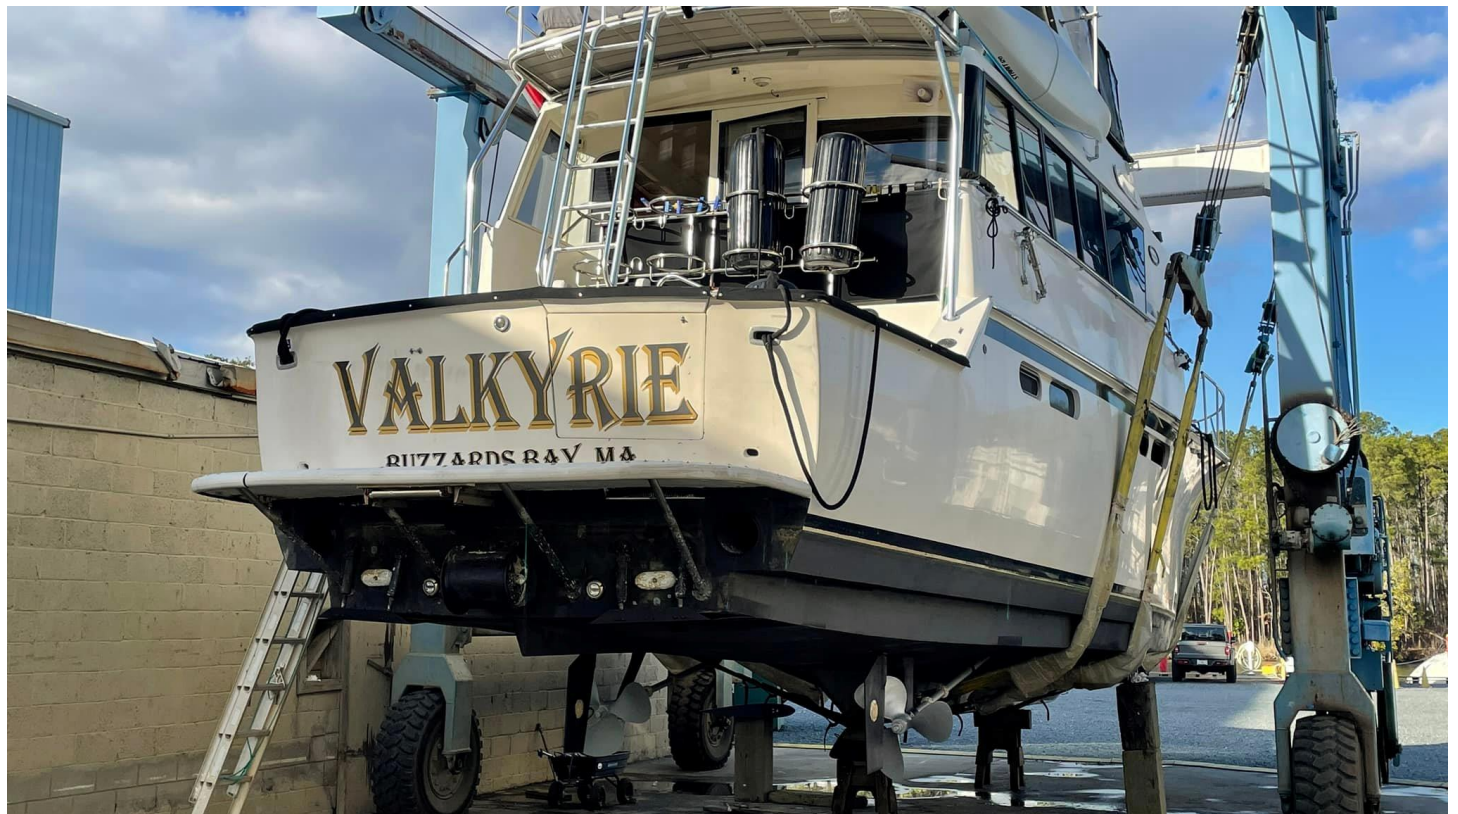
So we were hauled out today and had a very productive successful day. The stabilizer fins have been serviced and repaired and tested well. We removed the muskrat guards which were rather restrictive for the big Detroit Diesel exhausts so now the engines can breathe better with no backpressure. They were through-bolted so we glassed in the holes. I also replaced both underwater lights on the back of the boat. We had the bottom of the boat pressure washed scraped and cleaned off barnacles and other crustaceans and then had anti-fouling anti-crustacean paint applied to the strainers, propellers, and propeller shafts. They also bottom painted any bare areas and anything that needed it.
