Follow along with us as we cruise onboard our 56' Ocean Yacht.

Somewhere on the Water

Update February 1, 2023 – February 28, 2023

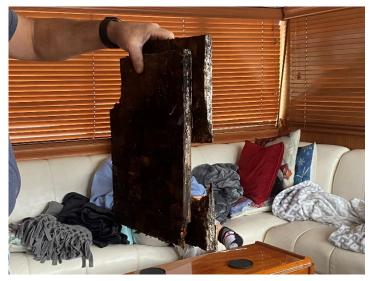
Step 1: Tearing up the Amtico flooring (which later we decided to reuse)

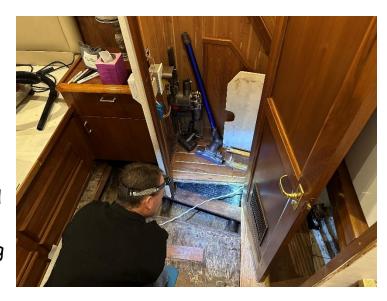
Step 2: Remove the rotten plywood. Discovered that there was a previous repair made in this location; the plywood was not marine-grade which contributed to how quickly it went bad.

Step 3: Removed the standing water and then determined the best solution to getting the water to drain into the bilge.

Using a multitool saw to cut a sliver of the fiberglass out between the exterior wall and the floor so that the water could drain. Mark also cut out the space for the water to drain where the new washing machine catch pan was going to be.

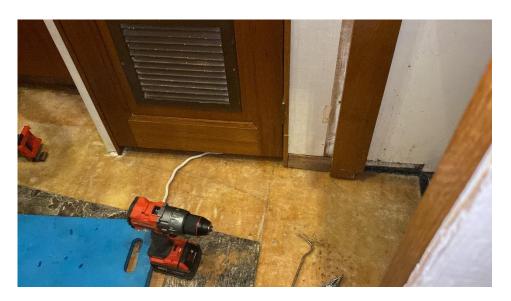
Step 4: Place new marine-grade plywood down.

The new plywood was coated with epoxy resin as well as the existing old flooring which took a couple of days to cure.

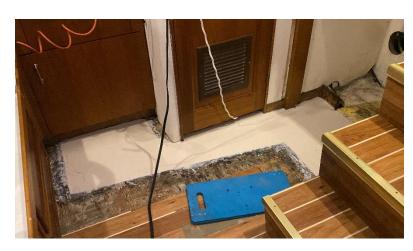
Step 5: After the new plywood and existing plywood were coated with the epoxy resin, Mark put a layer of fiberglass down.

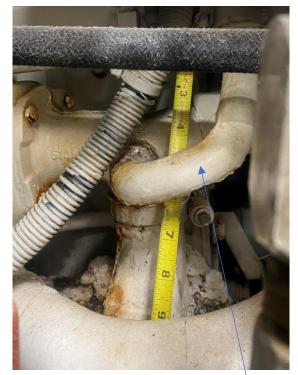
This is the broken pipe before it was removed.

Originally the pipe cover had a curved solid pipe that was braised and welded onto the pump cover. That braised solid pipe was rotted through and leaking. Once he had that pipe removed he had that hole reamed out and threaded so he could thread in a male barbed elbow. A new, longer piece of hose was installed to stretch across to the existing receiving pipe.

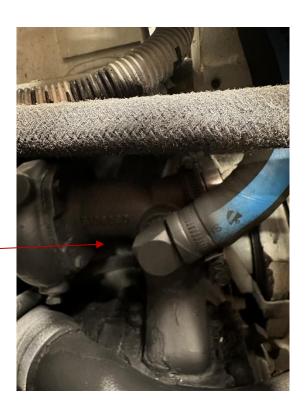
The new elbow and hose.

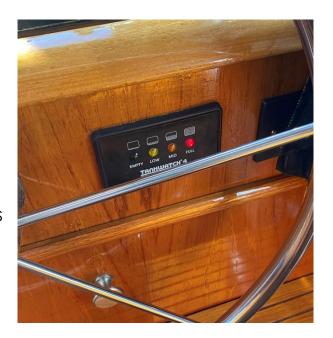
Mark has tinkered with this meter a few times and hopefully, this time is the last. Tweaking the position of the magnets that are inside the tank is not difficult. It is a two-person job, however. I watch the tank meter and call out the level as they light up until the magnets are in the correct position.

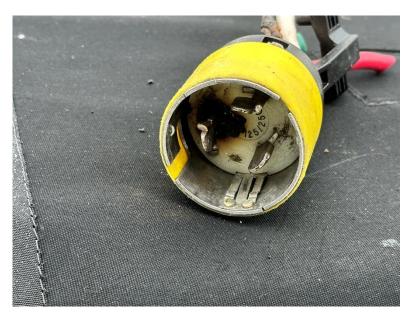
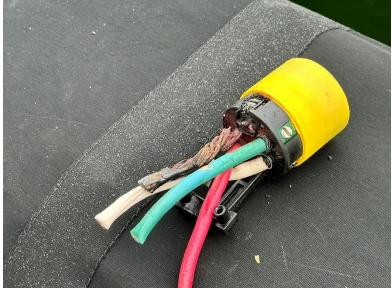
As often as possible during cruising times or while at our seasonal marinas, we try to do a starboard tie-up. The starboard power cord is longer, our water tank access is starboard side, and we can lower the dingy, to name a few reasons. This winter at Fiddlers Cove Marina is no exception, we have a starboard tie-up. Not too long ago Mark had to replace the starboard shore cord plug. Mark watches our electric panel daily. The electricity that we draw from running the 4 electric heaters, plus our everyday appliances needs to be monitored. We have tripped a few breakers this winter here on our panel, outside on our pedestal, and the whole dock. On this particular evening, it was more than just a tripped breaker. Whether this was our fault or a problem with the pedestal we are not sure.

This happened in the evening of course; after stores are closed so we had to pull out the port shore cord and run it alongside the boat. This meant Mark had to walk along the side of the boat to prevent the cord from falling into the water. You've seen him do that...
